Manhole Inspection Summary

Manhole # S45C__026MH

Insp Date: **8/18/08 11:10 AM**

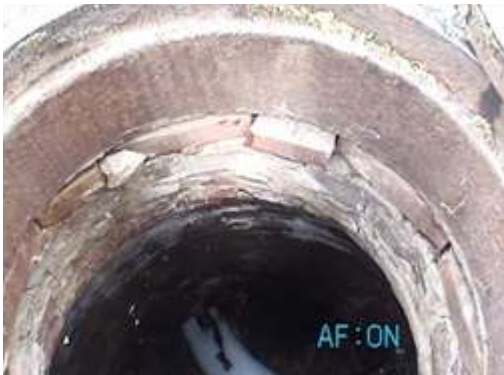
Defect 2

Condition: ☐ Sound ☐ Cracked ☐ Root Intrusion ☒ **Loose Brick** ☐ Deteriorated

Infiltration: ☐ None ☐ Joint ☐ Cracks ☒ **Mortar** ☐ Roots ☐ Wall

Loose brick

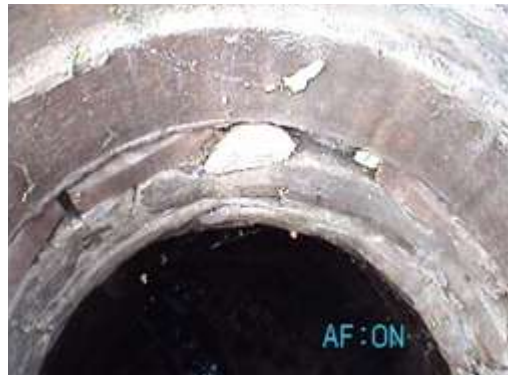
Defect 1

Deterioration

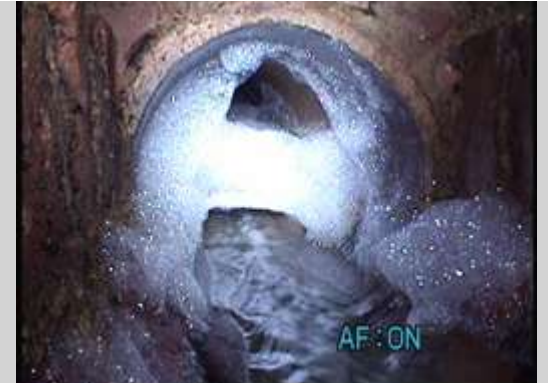
12 O'Clock Outflow

Pipe Height: **8.4** (in.) Rod and Bar (Angled)
Pipe Material: **Clay** ☐ Pipe Lined
Invert Depth: **8.65** (ft.) Flow Characteristics: **Fast**
Deposits: ☒ None ☐ Mud ☐ Sludge ☐ Debris ☐ Grease
Silt Depth: (in.) Deposits Extent:
Infiltration: **None** Pipe Seal Cond: **Sound**

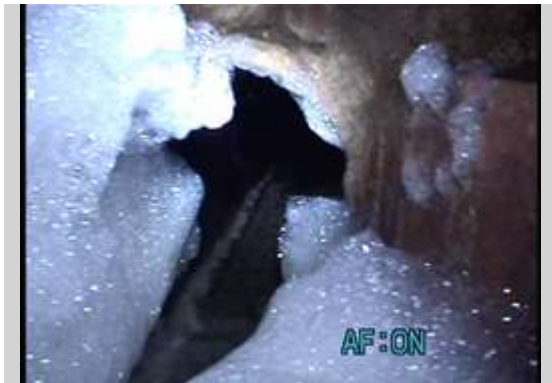
9 O'Clock Inflow

Pipe Height: **8.4** (in.) Rod and Bar (Angled)
Pipe Material: **Clay** ☐ Pipe Lined
Invert Depth: **8.60** (ft.) Flow Characteristics: **Fast**
Deposits: ☒ None ☐ Mud ☐ Sludge ☐ Debris ☐ Grease
Silt Depth: (in.) Deposits Extent:
Infiltration: **None** Pipe Seal Cond: **Sound**
